DEMAND GENUINE KUBOTA

KUBOTA Reman

Exclusively for
Kubota Industrial Engines

RESPONSIBLY REMANUFACTURED

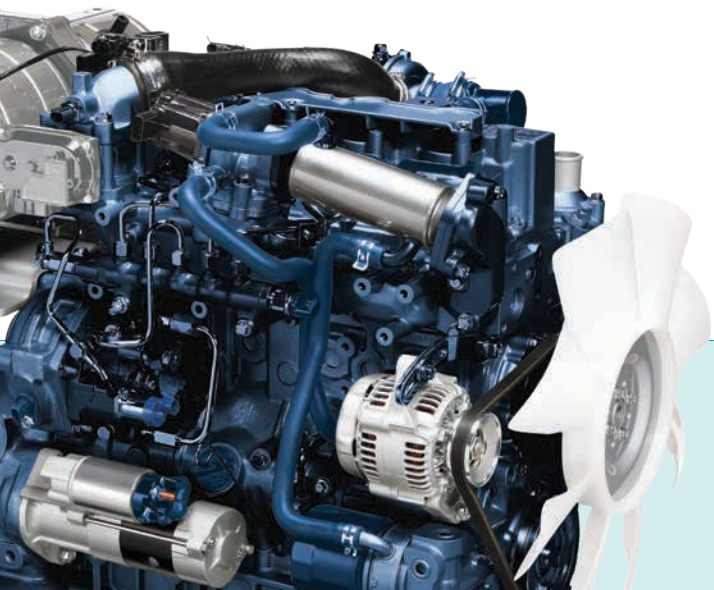
Test Starter #1

After completing 22,497 starts the brush material remains in contact with the starter armature. This **remanufactured** starter still has several starts before brush failure.

The wrong brush material composition resulted in short **aftermarket** starter life due to excessive brush wear resulting in loss of brush contact to the armature.

Passed
with 22,497 starts

Failed
after 3,593 starts
